# 2009 Water Chestnut Management Program: Lake Champlain and Inland Vermont Waters

## FINAL REPORT

A Report Prepared for the Lake Champlain Basin Program

Vermont Department of Environmental Conservation  
Waterbury, Vermont

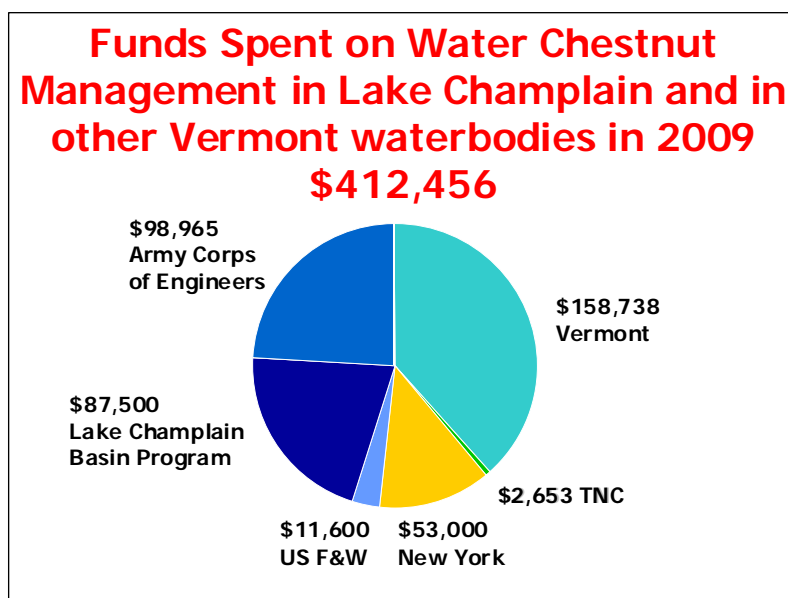
**Figure 1-1.** Summary of funds spent managing water chestnut in Lake Champlain and other Vermont waterbodies in 2009.

Funds spent on water chestnut management efforts in Lake Champlain and other waters in Vermont in 2009 totaled \$412,456 (Figure 1-1). Funds spent on management since 1982, are estimated at \$8.3 million (see Table 1.1).

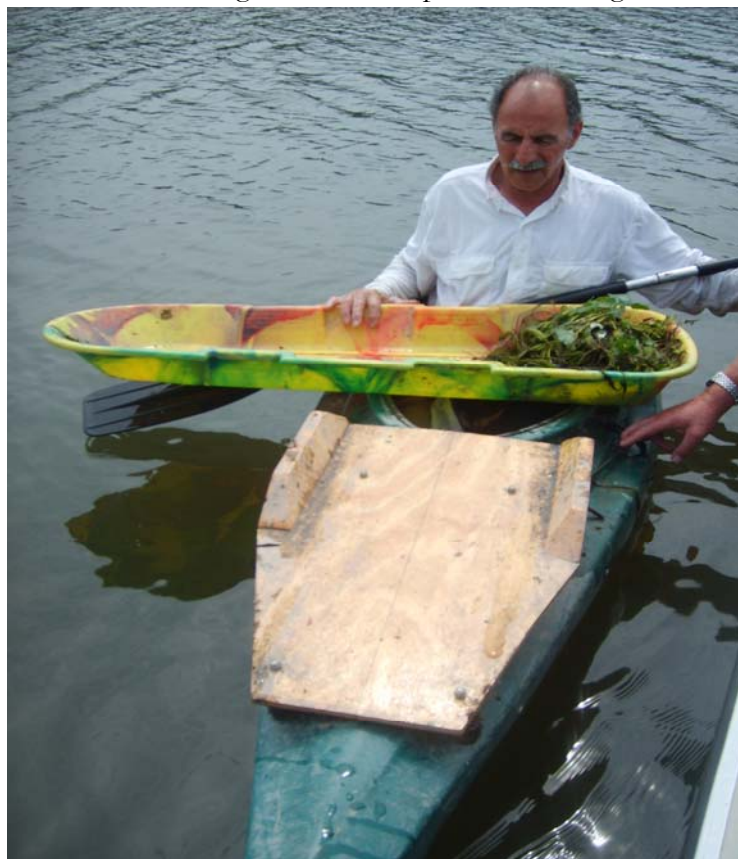
**Figure 2-2.** Lakeside Restoration’s newly developed water chestnut container system for offloading spoils from a kayak VTDEC

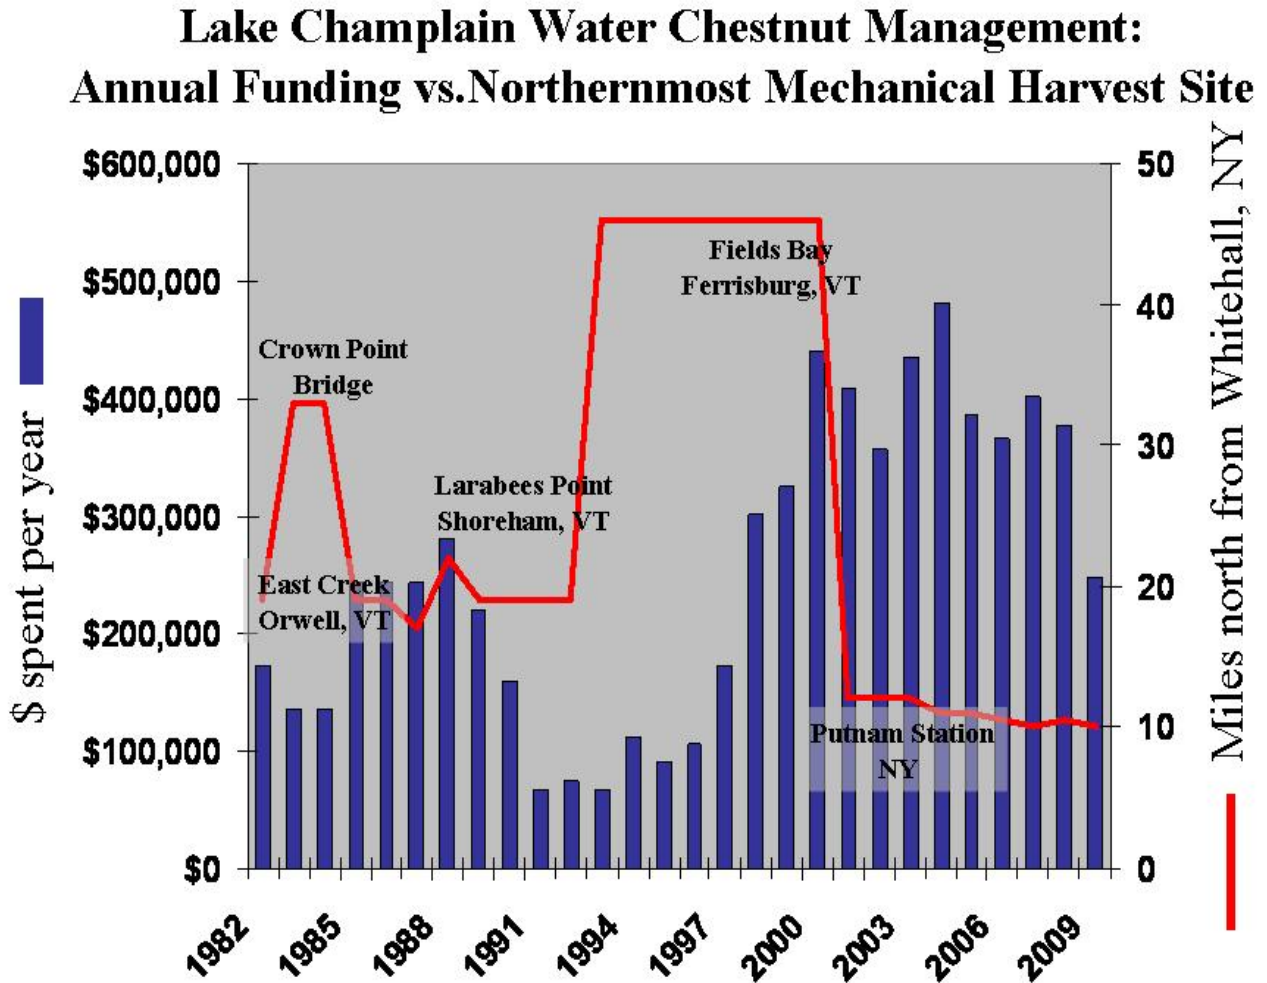
Figure 2-5. Annual water chestnut funding vs. northernmost mechanical harvest site in Lake Champlain, 1982-2009.

- As of 2009, the northernmost mechanical harvesting site in Lake Champlain a site by the railroad tracks near New York Light 4 (site #44), Putnam, New York.

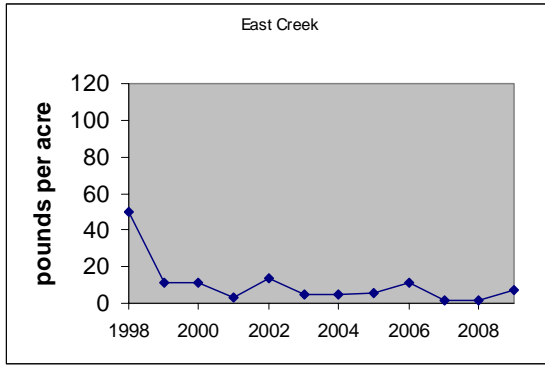
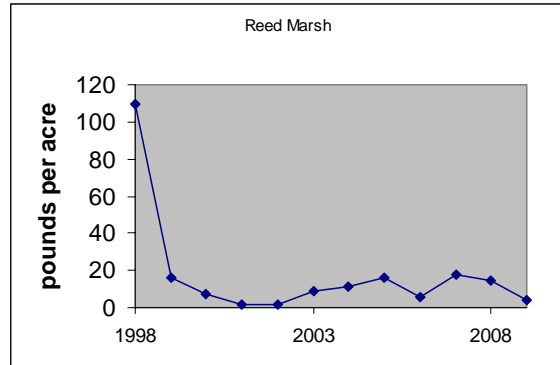
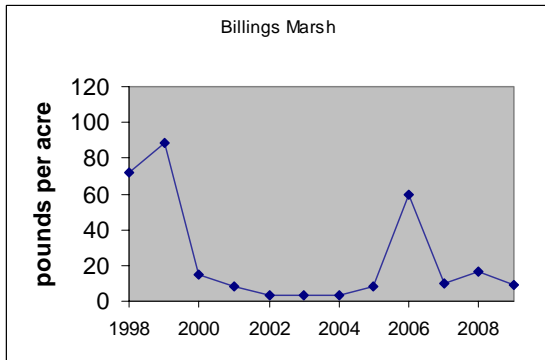
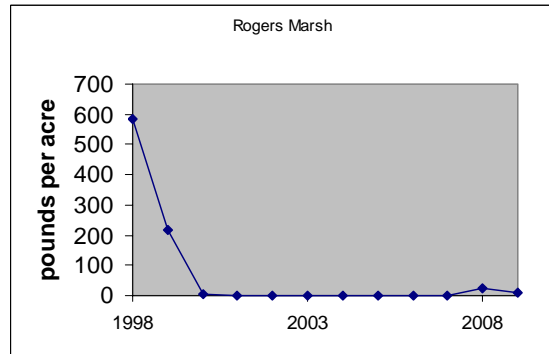
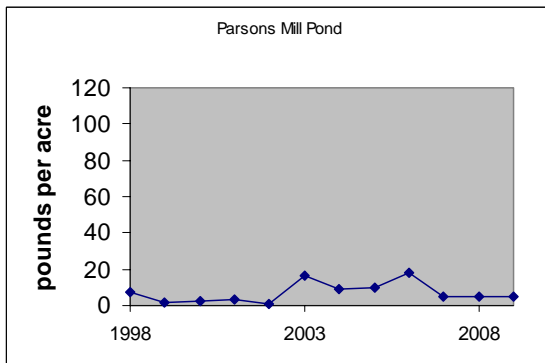
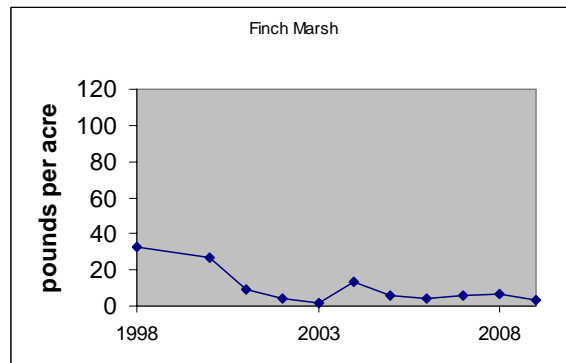
**Figure 3-1a-f. Water Chestnut harvest trends at six sites in the Southern Lake Champlain Valley, 1998 – 2009.**

Water chestnut harvest continues to exhibit an overall pattern of decline or stabilization at all sites visited in 2009 (Table 3-4; Figure 3-1 a-f). Overall, 19 sites are isolated enough from the influx of water chestnut propagules from other areas to be considered responsive to management efforts. Of these sites, a number exhibited moderate increases in harvest weights (East Creek), while the remainder yielded either minor increases or decreases in harvest weights compared to 2008 (Table 3-5). As in previous years, few major changes were observed in harvest weights, no and major shifts in infestation intensity were observed.

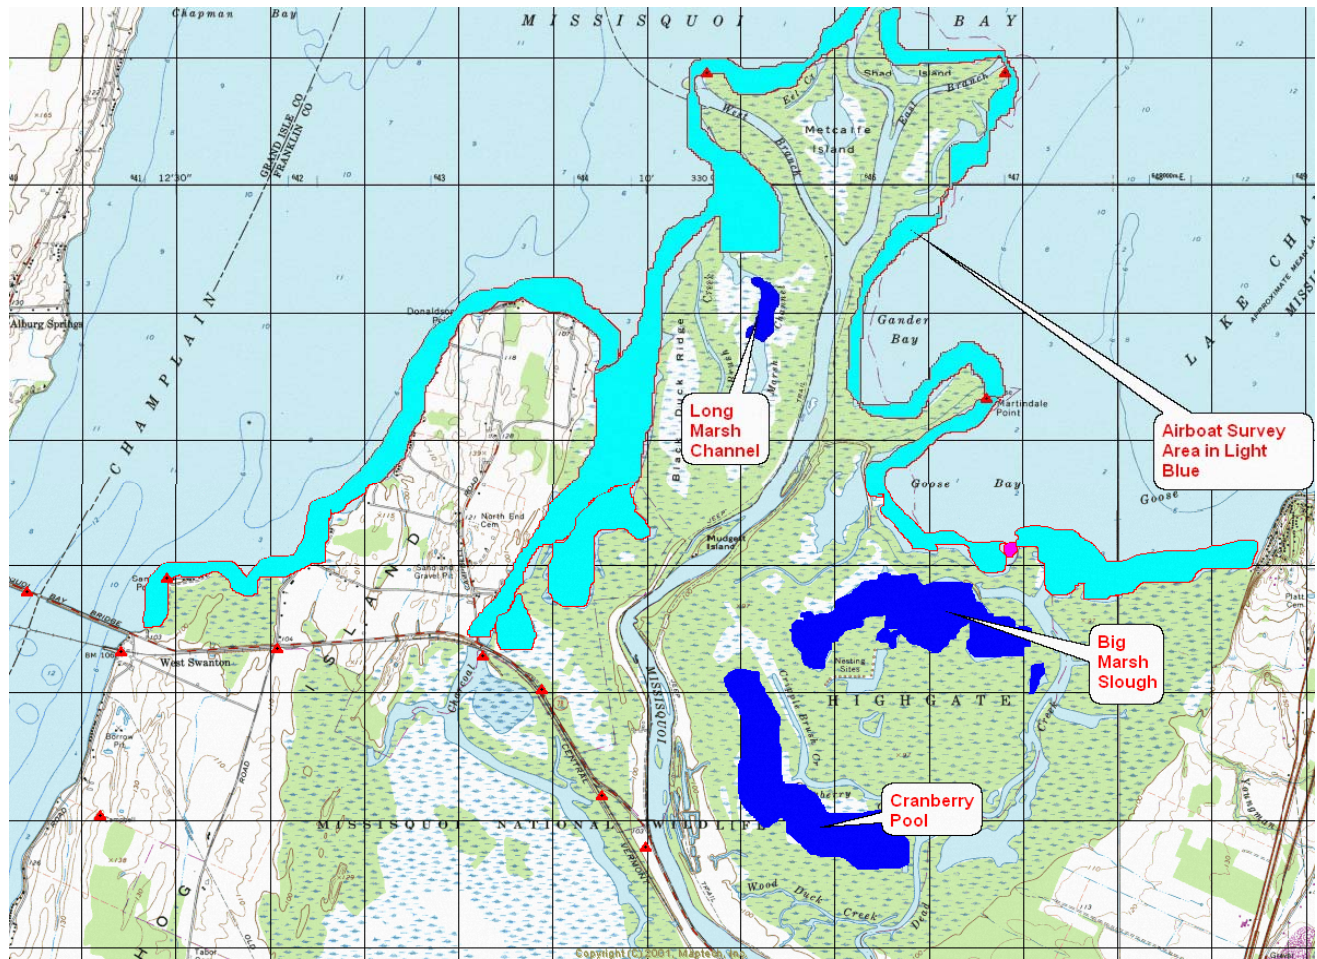
Map 1. Northern Lake Champlain sites: Missisquoi Bay.

Key: pink = two water chestnut rosettes found in 2009, none found 2008  
light blue = airboat search area  
dark blue = currently known and managed water chestnut sites
